1. Protect your staff and customers from collision with fork lifts

IRIS60/8 SENSOR

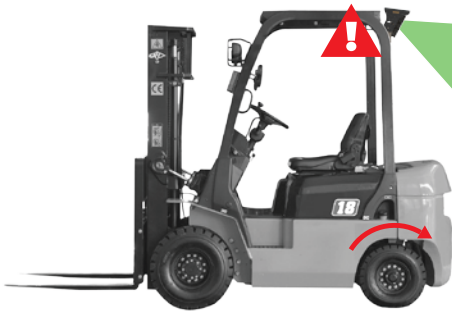
Audible driver and pedestrian alert
