Seen sensor monitors vehicle blind-spots

IRIS60/8 SENSOR

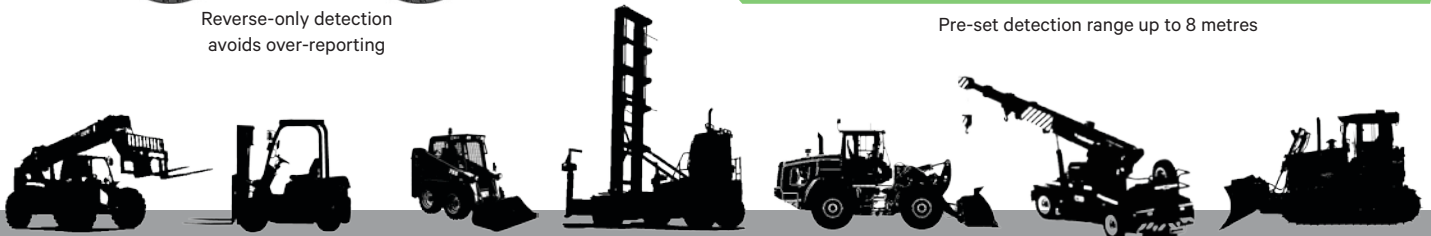
Reverse-only detection avoids over-reporting

Pre-set detection range up to 8 metres
