IRIS60/8 SENSOR

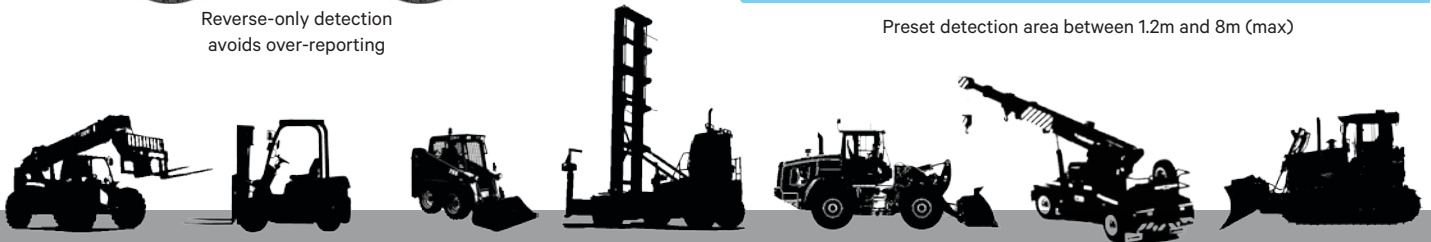
Reverse-only detection avoids over-reporting

Preset detection area between 1.2m and 8m (max)
